NUREG/CR 1127
NRL Memorandum Report 4121

**Fractographic and Microstructural Analysis of Stress
Corrosion Cracking of A533 Grade B Class 1 Plate and
A508 Class 2 Forging in Pressurized Reactor-Grade
Water at 93°C**

January 25, 1980

NAVAL RESEARCH LABORATORY
Washington, D.C.

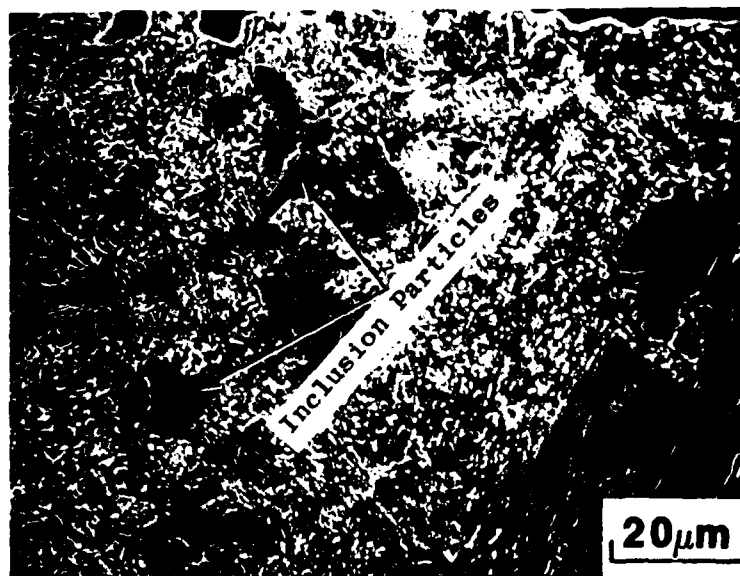
The SEM micrographs in Fig. 3 show typical features of the microstructure of A533-B-1 plate and A508-2 forging materials; these micrographs were taken from the polished and etched sections of the two specimens. The microstructure of the A508-2 forging (Fig. 3a) shows several inclusions and coarse carbides. On the other hand, the microstructure of the A533-B-1 plate (Fig. 3b) shows smaller carbides and fewer inclusion particles. An additional microstructural evaluation of the two steels showed that the microstructure of A508-2 forging was ferritic-pearlitic with small amounts of bainite, whereas that of A533-B-1 plate was completely bainitic. Figure 4 is a montage of SEM micrographs of a polished and etched section of A508-2 specimen showing one of the many microcracks that were present in this specimen. The microcrack started from the outside surface and propagated along the inclusion-matrix material interface. As can be seen in the micrographs, decohesion also occurred along the carbide-matrix interface. The SEM micrographs presented in Fig. 5 are higher magnification micrographs of the crack tip areas of the cracks shown in Fig. 1b and 2a and the microcrack in Fig. 4. Small voids are observed in the vicinity of the crack tip in both cases. These voids are similar to ones observed in a parallel study of the fatigue crack growth resistance of A508-2 forging steel in reactor-grade water at temperatures up to 288°C (550°F) [8]. In that study it was suggested that the small voids are the sites to which hydrogen can most easily diffuse and be trapped.

Fig. 3. SEM micrographs of A508-2 forging and of A533-B-1 plate specimens. The micrographs were taken from the transverse sections of the specimens. The microstructure of A508-2 (Fig. 3a) is characterized by large amounts of carbide and inclusion particles; the microstructure of A533-B-1 (Fig. 3b) has fewer carbide particles and it is almost free of inclusions.

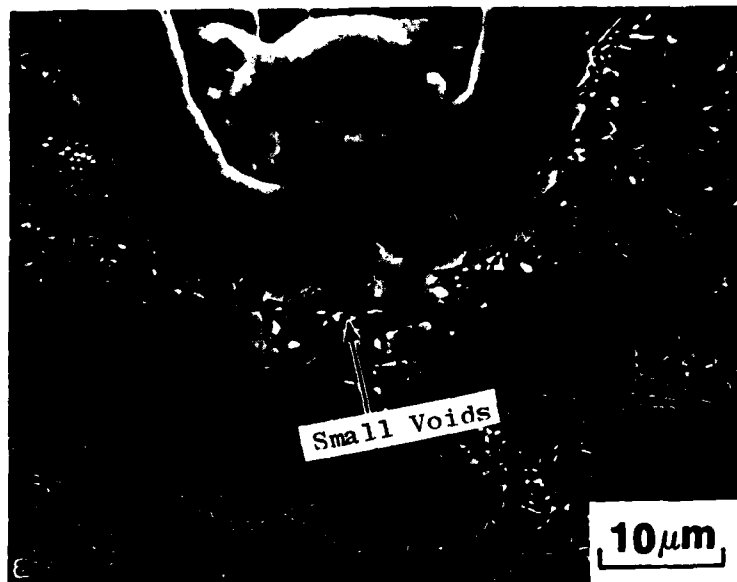
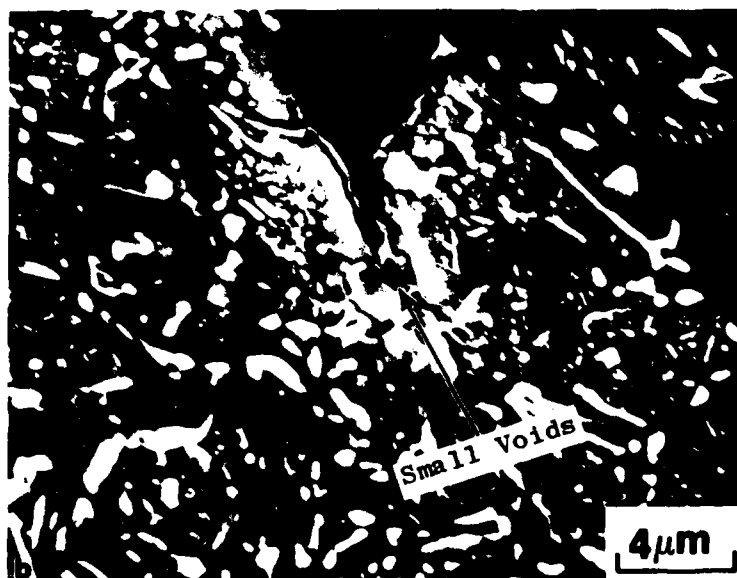
Fig. 5. SEM micrographs of transverse sections of A508-2 tensile specimen. Micrograph (a) is an enlarged view of the crack tip shown in Figs. 1b and 2a; micrograph (b) is an enlarged view of the tip of the microcrack shown in Fig. 4. The micrographs show the presence of small voids near the tips of both cracks.

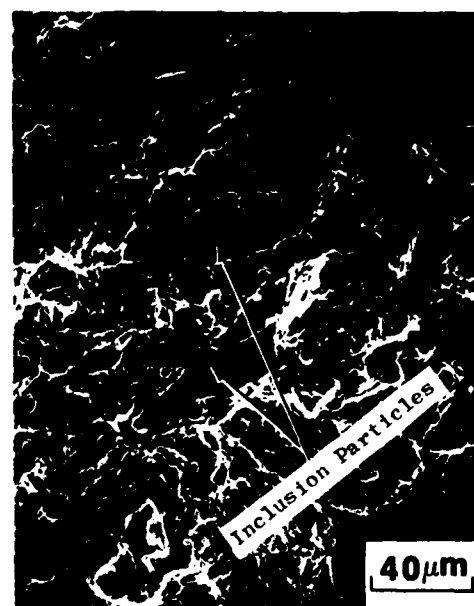
The significant fractographic features observed on the stress corrosion area in one of the several cracks found in the A508-2 specimen are illustrated in the SEM micrograph presented in Fig. 6. Figure 6a is a lower magnification micrograph that gives a general view of the stress corrosion area. The failure mode appears to be cleavage-like and inclusion particles are clearly visible on the fracture surface. The inclusions are quite evident in the adjacent higher magnification micrographs (Fig. 6b and c). The inclusion particles have an elongated shape and they are quite numerous. Panel (d) of the same figure is the energy dispersive x-ray spectrum of a small region in the stress corrosion area near an inclusion particle. The spectrum, besides the expected peaks of iron and chromium, reveal the presence of manganese, silicon and sulfur peaks and a small chlorine peak. The spectrum indicates that the inclusion particles are manganese-sulfide and silicate inclusions. The x-ray image scans presented in Fig. 7 refer to manganese and sulfur; similar image scans were obtained for the silicate inclusions.

Fig. 6. SEM micrographs (a, b, and c), and energy dispersion x-ray spectrum (d) taken from the stress corrosion crack of a A508-2 tensile specimen. This stress corrosion crack became accessible for SEM examination when one half of the specimen was broken at liquid nitrogen temperature along one of the several cracks that had developed on the gage sections. Micrographs a through c show cleavage-like fracture propagation along inclusion bands. The x-ray spectrum shows that the bands are silicate and manganese-sulfide inclusions.

A hydrogen-assisted cracking model has been developed to explain the above results. When the test specimen is exposed to a pressurized reactor-grade water at 93°C, an oxide layer is formed on the surface consisting mainly of hematite. Hematite is not protective, thus allowing further corrosion reactions to occur. Due to the presence of manganese-sulfide and silicate inclusions, the prevailing electrochemical conditions initiate a localized corrosion attack on the metal matrix around the inclusions [9,10] and a decrease of pH occurs [11,12]. Also the solubility of MnS even in pure water allows the formation of a sufficient concentration of HS⁻ ions, which accelerates the corrosion reaction and hydrogen evolution [11,13]. Further enhancement of the corrosion attack may be caused by the migration of the chlorine ions into the crevice [9]. The energy dispersive x-ray spectrum shown in Fig. 6d provides support for this hypothesis.
